# BUILDING INSPECTION

123 Test Street, Sydney NSW 2000

11th December, 2023

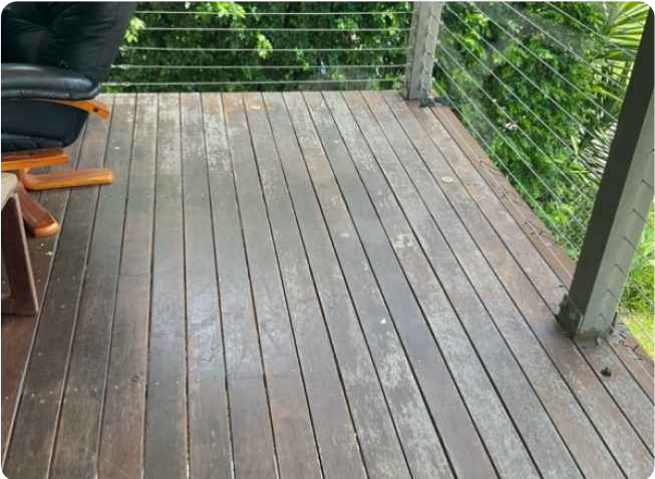
| Deck | | | | | | |

| Inspector Note:<br>The timber deck has suffered from decay and rot due to inadequate maintenance and exposure to moisture. It is structurally compromised and needs to be replaced or repaired to prevent injury. | | | | | | |

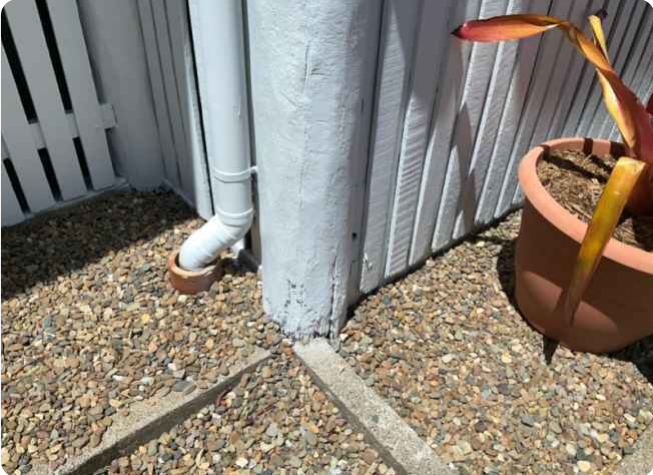
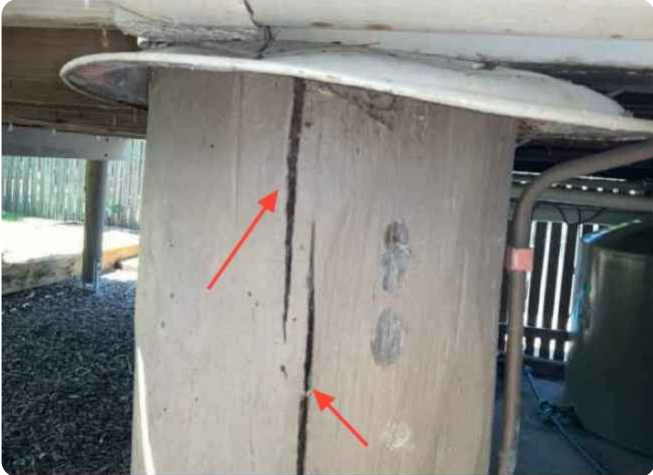
| Status of floor stumps at time of inspection | Major Defect |
| There is evidence of fungal decay at ground level and termite damage. | |

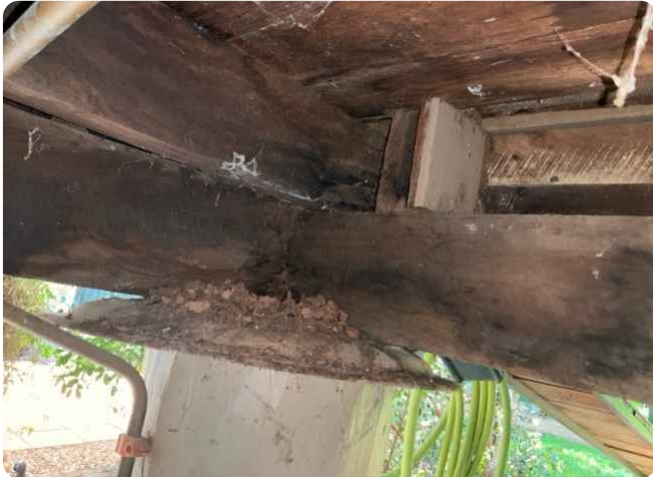
Floor Framing

There is evidence of both moisture damage and termite damage in the affected areas.

Showing example of damage

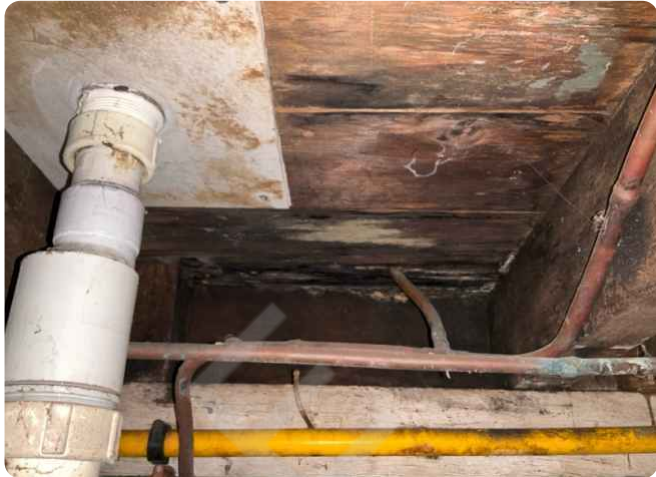
Showing example of damage

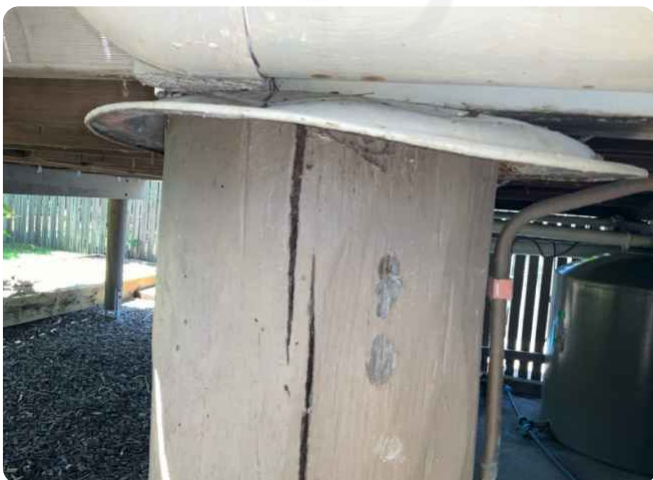
Major Defect

Defect statement: Ant capping rust is present on the structure.

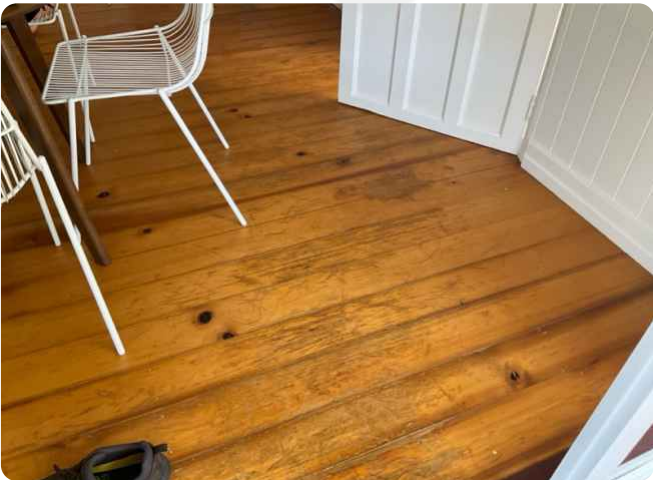
| Dining Room | |

| <p><b>Inspector Note:</b></p> <p>There are general age defects present in the timber floor.</p> | |
